# Birdsview Concrete

Scan first, decide better: non-destructive  
concrete insight as a tool for Nordic circular  
cities

# Nordic Smart City Circular Fast Track

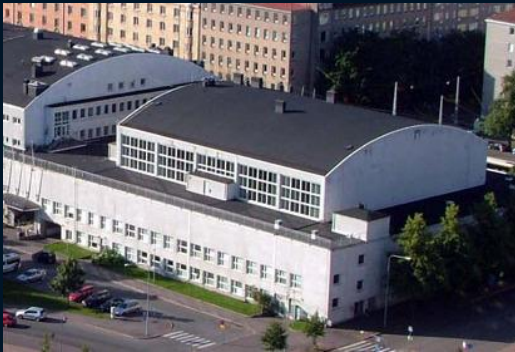
**Töölö Sports Hall**  
Rebar structure, beam localisation

## Case 3: Töölö Sports Hall, Helsinki

- Investigation of the reinforcement structure in the basement beams, and localization of beams above the ceiling slab from underneath.
- The primary objective was to investigate the reinforcement structure in the basement beams, and in particular to test the hypothesis that some rebars are bent upwards near the beam support — a configuration used to handle shear forces rather than bending moment

- The sports hall scanning presented the most geometrically challenging conditions of the three pilot assets, due to beams built in this era being less standardised than today's solutions. The tight clearance between the beam and the surrounding slab required a more tricky scanning approach.

- Despite these constraints, the scanning delivered useful structural information: probable beam positions above the ceiling were identified, column reinforcement was mapped with good confidence, and the investigation of basement beam behaviour near supports produced data consistent with the hypothesis of shear reinforcement.

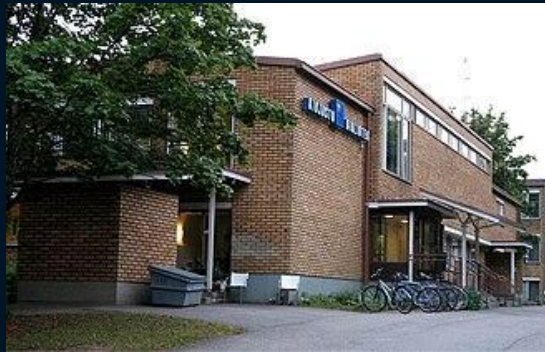
**Etelä-Haaga Library**  
Cover depth, load capacity for retrofit

## Case 2: Etelä-Haaga Library, Helsinki

- Etelä-Haaga Library is a public library in the Etelä-Haaga district of Helsinki, managed by the City of Helsinki. The building is part of Helsinki's broader public building portfolio, where upcoming maintenance and retrofit decisions are planned.
- The scanning focused on mapping the reinforcement structure in load-bearing beams and columns — information that is critical for fire engineering assessments and for evaluating the structural capacity of the elements ahead of any planned retrofit or maintenance work.
- The focus areas were agreed on site: reinforcement cover in beams and columns . showing Bracing/stirrups in some locations: as little as 10 mm from the surface, and general rebar structure, with diameter estimations.

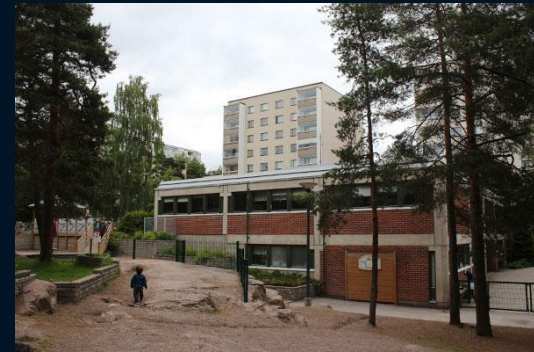
**Kuutamon Päiväkoti**  
Prestressing strands for slab reuse

## Case 1: Kuutamon Päiväkoti, Espoo

- Kuutamon Päiväkoti is a low-rise brick and concrete daycare centre in Espoo, representative of a generation of smaller-scale municipal structure built during the rapid urbanisation of Finnish cities in the latter half of the twentieth century.

- The building is planned for conversion or decommissioning, and **hollow core slabs** from the structure have been identified as candidates for reuse in another project.

- To carry out structural calculations for reuse, documented knowledge of the number of **prestressing strands in the slabs** was needed — information not available in existing drawings.

- **Results:** A direct link between structural knowledge and circular economy outcomes: GPR scanning of the hollow core slabs are necessary — without it, neither the load-bearing capacity calculations nor the reuse decision itself could have been made on a sound basis.

- The findings are consistent with production drawings found for both slab types (HD265 and HD200 cross-sections)

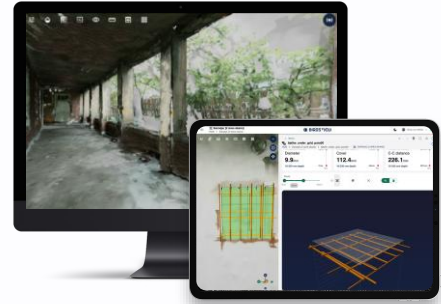
## 01 SCAN

- **Sensor Fusion** combining GPR radar, lidar and camera
- Captures data with **millimeter precision across large areas**
- **Only company globally** that combines this for concrete.

## 02 ANALYSE

- **AI-powered analysis** combines signals using Full Waveform Inversion.
- Automatically detects rebar, diameter, cover & key information about the structure with **millimeter accuracy**.

## 03 REVEAL

- **Complete digital 3D model** of the structures outside and inside
- **Data accessible anywhere, anytime**
