Vibration based predictive maintenance of HVAC-systems

Circular Fast Track

3 Cities across Finland and Denmark
Espoo, Helsinki and Syddjurs

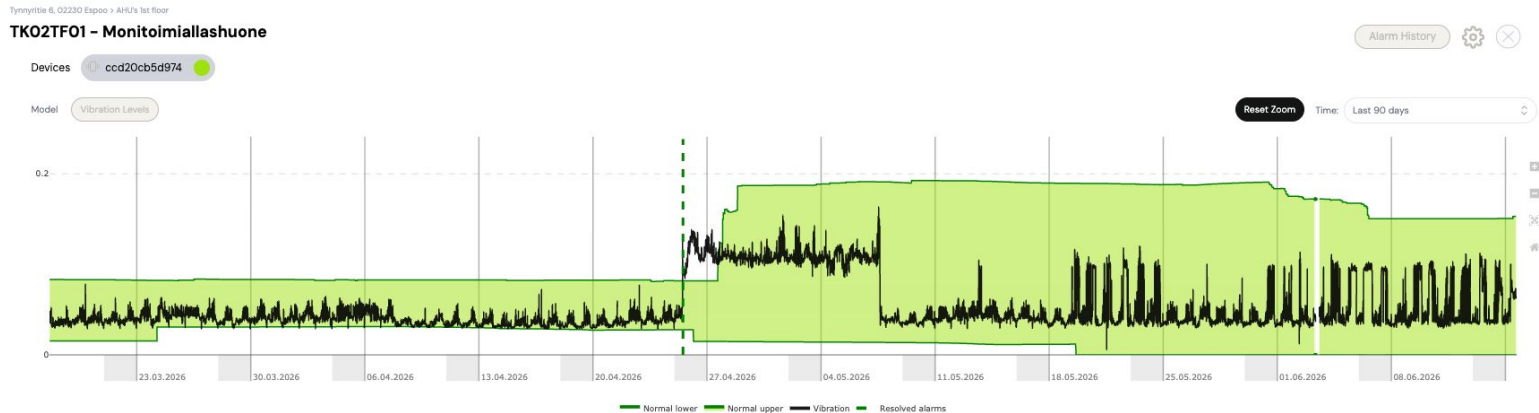
Alarm sent after visible change in vibration over a short period of time.

- The device settings were changed manually. A great alarm to see that changes made are detected by the Soundsensing system.

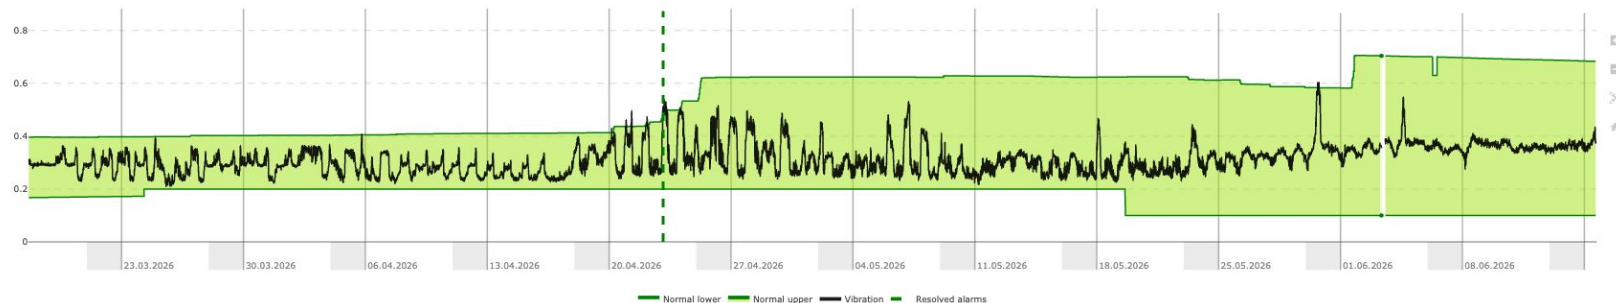
TK08TFO1 - Keittiö

Vibration levels in the unit was higher than expected. The alarm led to a manual inspection of the system. A slight chirping sound was heard from the unit.

- An exciting case to follow as we also see a new peak in vibration afterwards.

Kiinteistönhoitajan tarkastuksen perusteella TK08TFO1 pitää hieman sirttävää ääntä. Muuten ei poikkeavaa toimintaa. Tilannetta seurataan. // Based on the property manager's inspection, TK08TFO1 is making a slight chirping sound. Otherwise, there is no abnormal activity. The situation is being monitored.

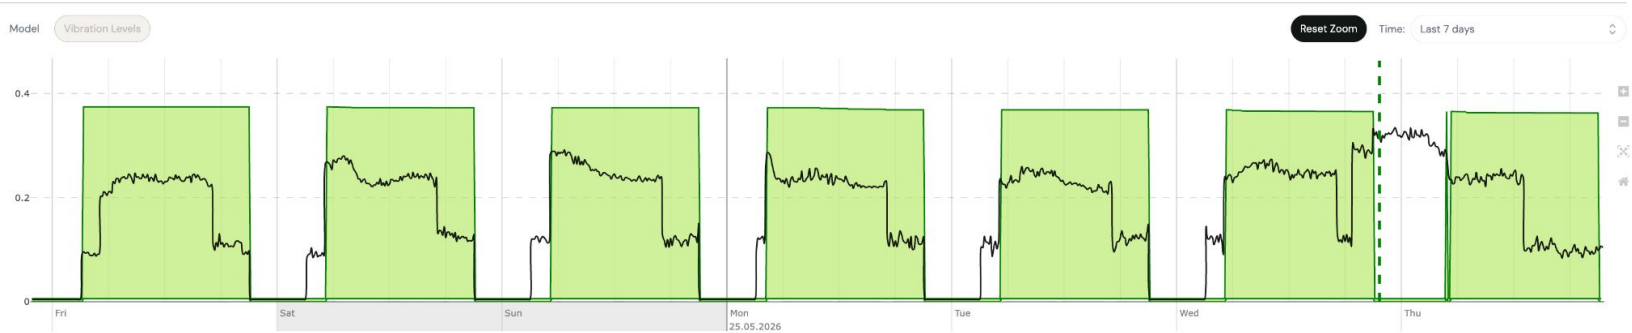
Alarm was sent when the unit did not turn off at night, as it was doing normally.

- Soundsensing makes it easy to spot when units does not turn on/off as planned. This provides major savings related to energy costs and wear and tear.

Estimated savings: €6,200 (through reduced energy consumption and lower equipment wear)

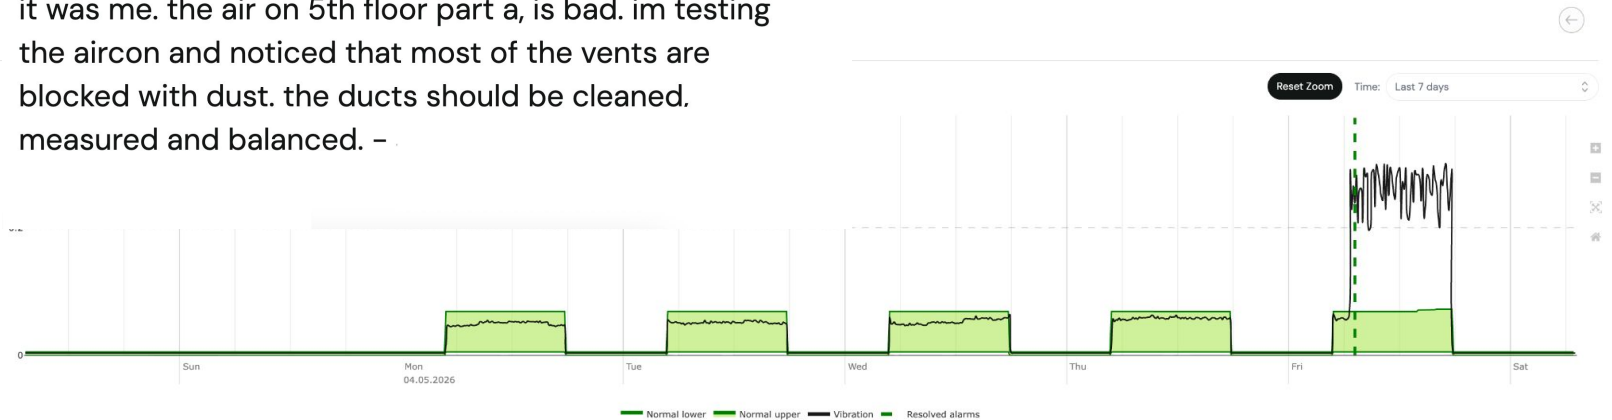
Rapid change in vibration.

it was me. the air on 5th floor part a, is bad. im testing the aircon and noticed that most of the vents are blocked with dust. the ducts should be cleaned, measured and balanced. -

Vibration levels are higher than expected.

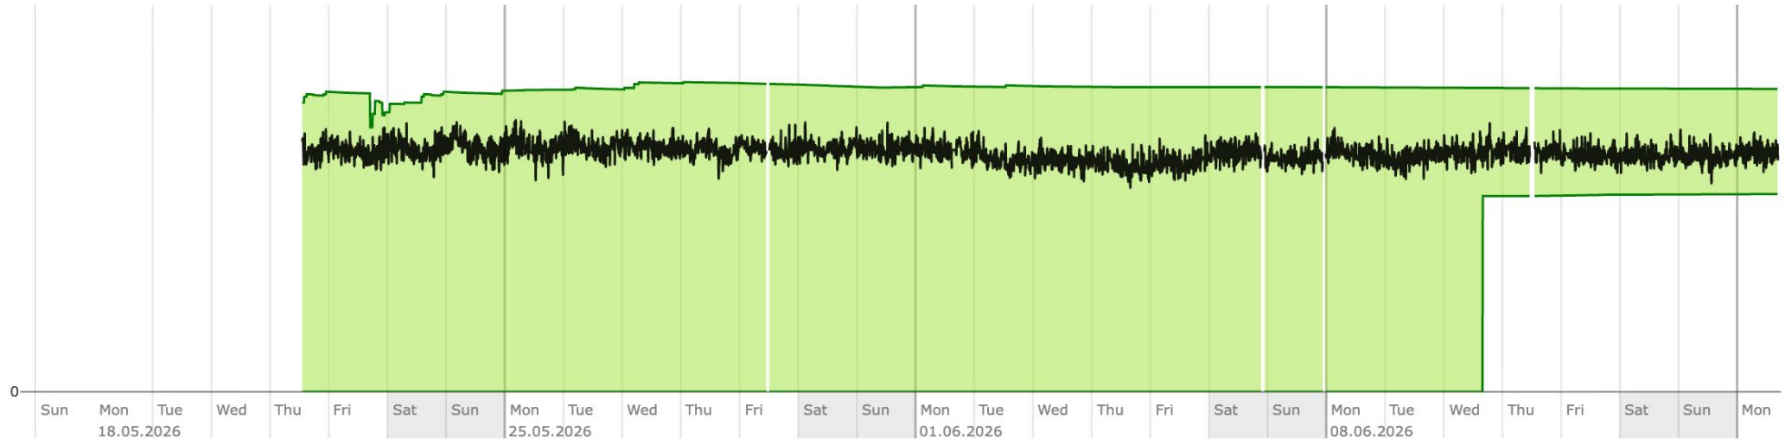
Vifte høyre

A common misconception is that the operating hours configured in the Building Management System (BMS) reflect the actual runtime of the equipment. In this case, the unit is scheduled to operate from 07:00 to 16:00. However, data from Soundsensing reveals that the unit is in fact running continuously, 24 hours a day, 7 days a week.

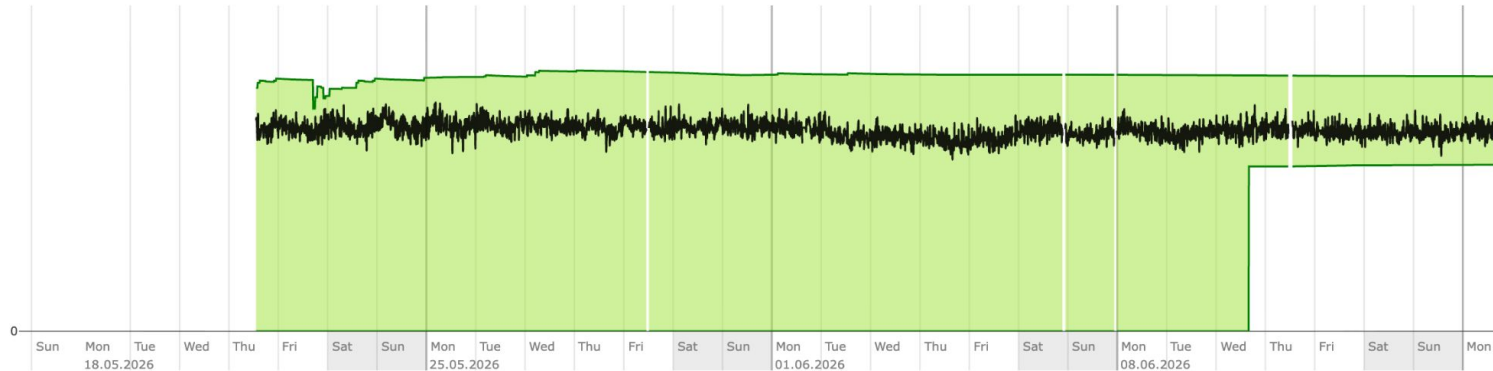
Vifte høyre

Findings

The unit is operating continuously, 24/7, despite being scheduled to run only during occupied hours. This results in unnecessary energy consumption and significantly increased wear and tear compared to a system operating 8 hours per day.

Recommended actions

Adjust the unit's operating schedule to align with actual occupancy requirements. Verify the changes and monitor performance through the Soundsensing dashboard to ensure the unit operates according to the new schedule.

Approximately **€10,300 per year** through reduced energy consumption and lower equipment wear
